PROBLEMS OF LANDSCAPE ARCHITECTURE
IN
THE NATIONAL FORESTS

REPORT TO U. S. FORESTER'S OFFICE
ON
TRIP OF INSPECTION THROUGH SOME OF THE NATIONAL FOREST AREAS
IN
REGIONS 2, 4, 6 AND 1

BY
A. D. TAYLOR
CONSULTING LANDSCAPE ARCHITECT
SEPTEMBER 1935

(July 26, 1935 through August 22, 1935)

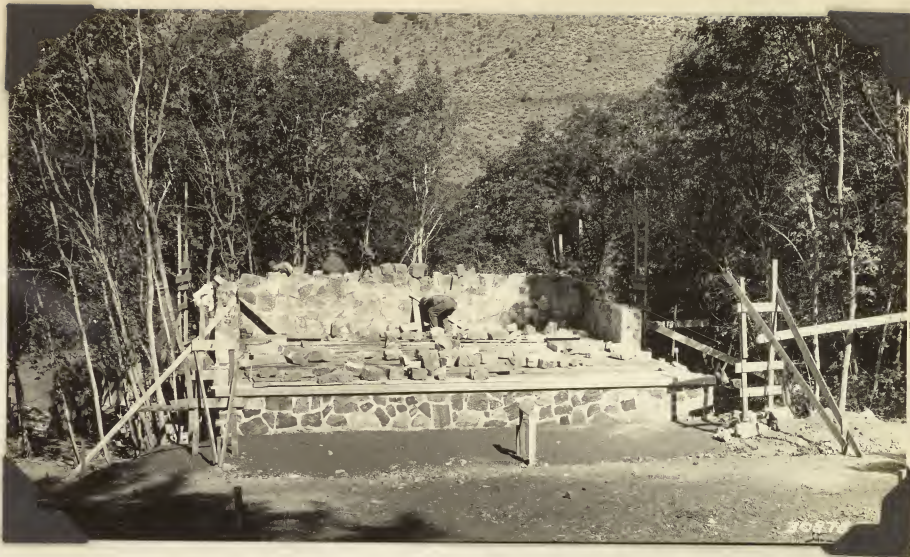
Cache National Forest - City Park Forest Camp in Logan Canyon

View from rear of amphitheatre looking towards the stage now under construction by CCC labor. A recommendation is made that the height of wall be increased at the sides of the back of the stage, and the circular arch in the middle of the back of the stage be omitted. An informal horizontal line should exist at the top of the stage work across the back of the stage.

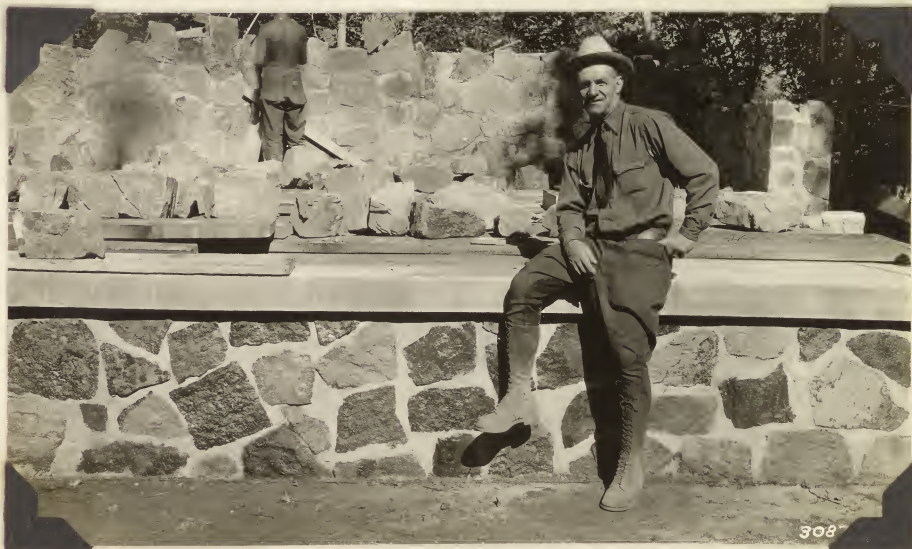
Cache National Forest - City Park Forest Camp in Logan Canyon

Detail view showing the texture of the stone work now constructed across the front of the stage. This stone work could be greatly improved by endeavoring to secure a "horizontal feeling" in this stone texture, through a careful selection and placing of the stones. For a general view, see photograph No. 308785 above.

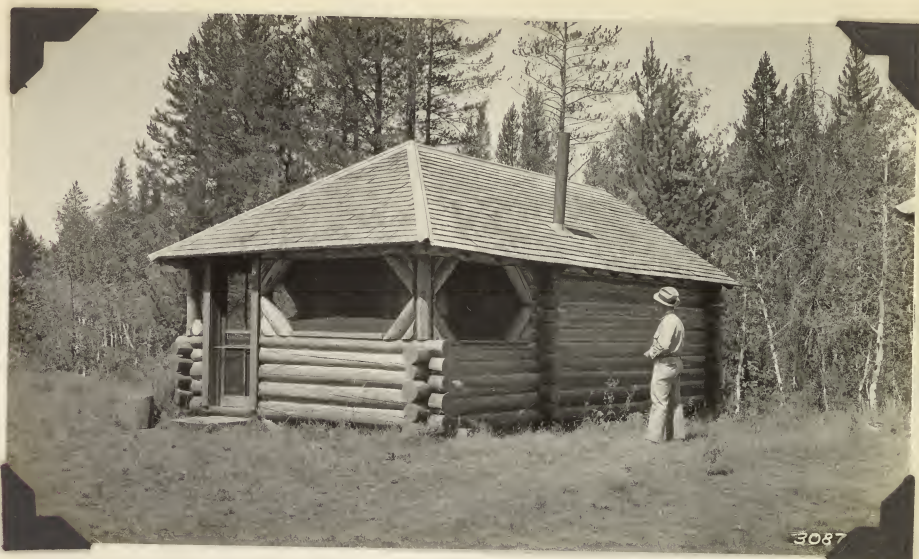
Targhee National Forest - Big Spring Forest Camp

Detail view of a most interesting and simple log cabin, which unfortunately is located in a very attractive open area. Such cabins should be located among the trees in attractive surroundings.

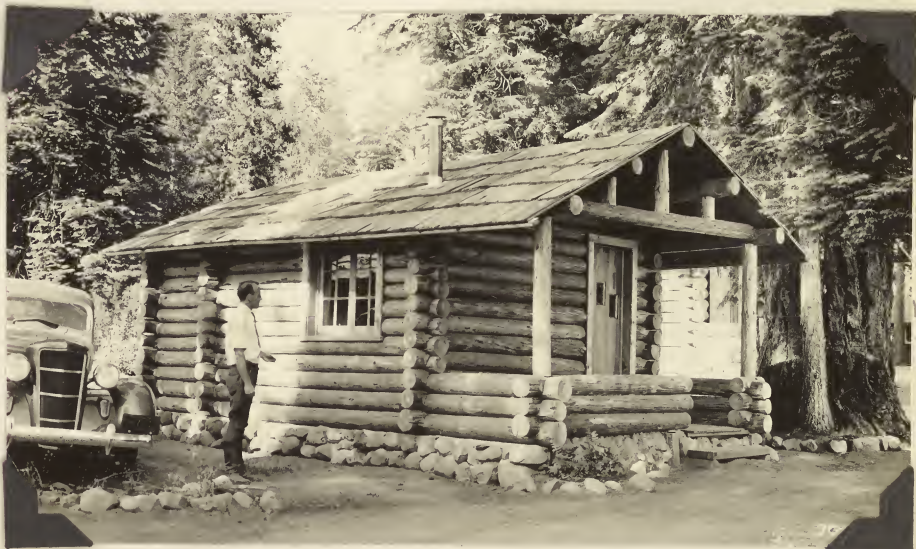
Deschutes National Forest - Crescent Lake

Detail view of a most excellently designed log cabin with an adequate stone masonry foundation. There is need of planting around the base of this structure.

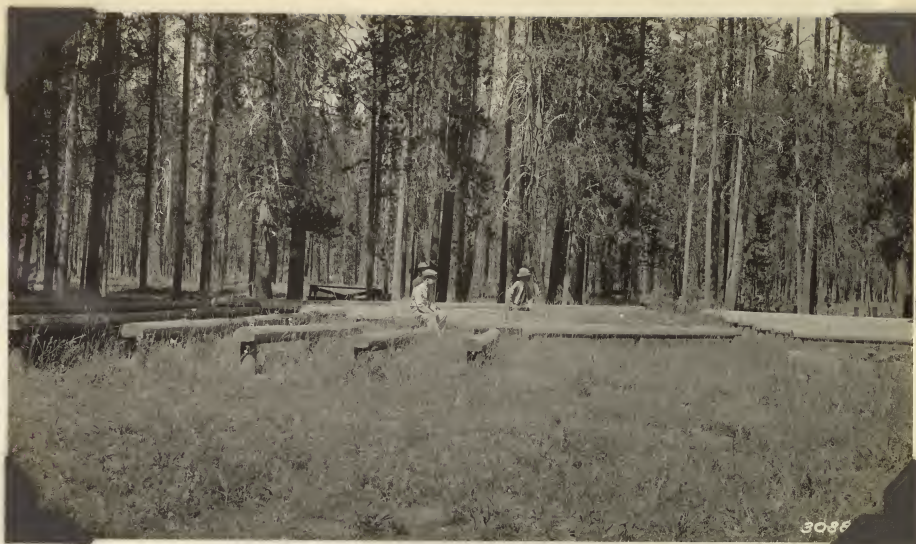
Targhee National Forest - Buffalo Forest Camp

General view of a community camp fire area. Note the log seats provided for those who gather in this area, and the location of the large campfire-pit (approximately 8 or 9 feet in diameter) on the right side of the photograph.

One of the most interesting features here is the community camp-fire area which is shown in photograph No. 308801 (page 85). I think that the seats could be somewhat more comfortable. The conception, however, is excellent.

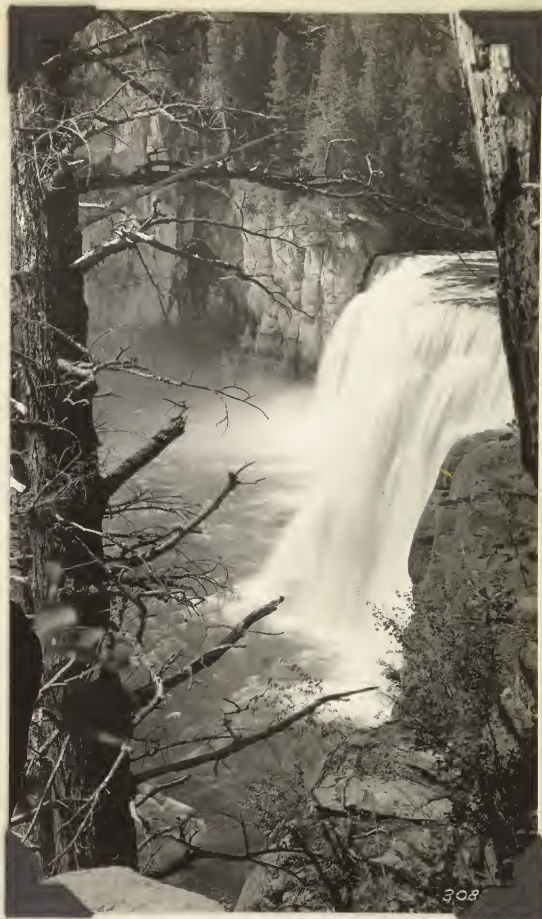
Targhee National Forest
Big Falls on Snake River

Detail view of Big Falls, - one of the outstanding scenic water features in the National Forest Areas. Unfortunately, that portion of land adjacent to the falls, and from which the best view may be obtained, is privately owned by the Utah Power Company. (Height of falls is approximately 110 feet). This area of privately owned land ought to be controlled by the Government for the use of the public.

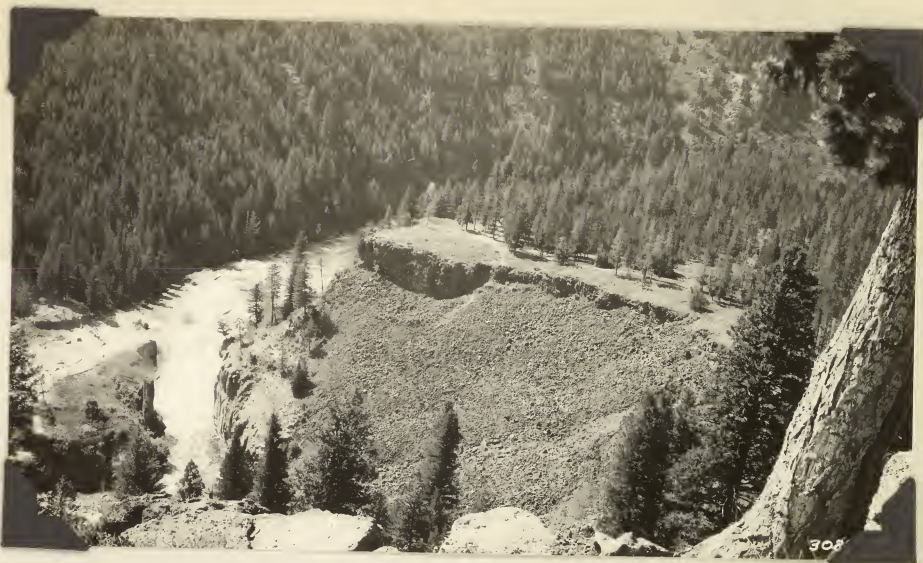
Targhee National Forest - Lower Falls on Snake River

General view of "Lower Falls" as seen from Grandview Point. Note the shelf of land above the falls being developed as a camp site and picnic area. Mr. Patridge has made an excellent sketch for the treatment of the Grandview Point overlook area.

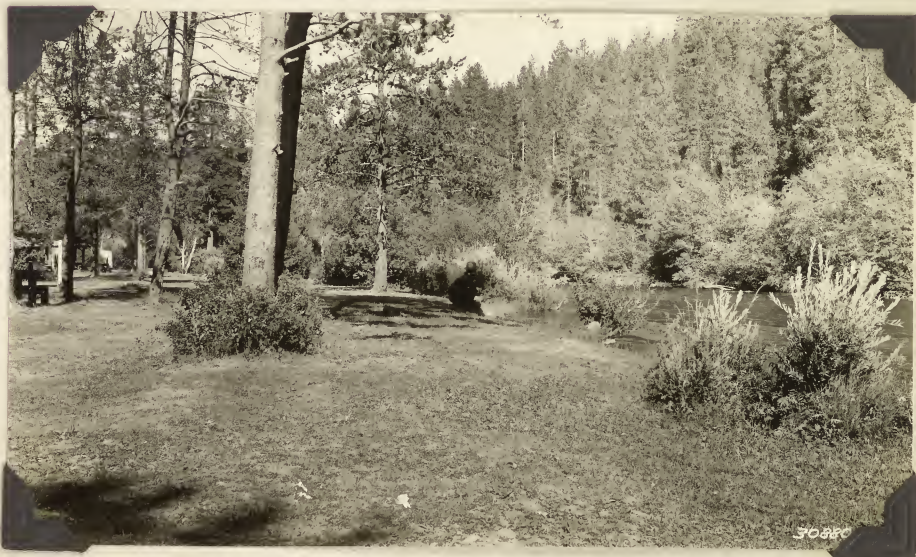
Targhee National Forest - Warm River Forest Camp

A general view showing a portion of this camp acre adjacent to the river. An effort should be made in such camp ground areas to avoid intensive use to the extent of entirely destroying the cover of turf.

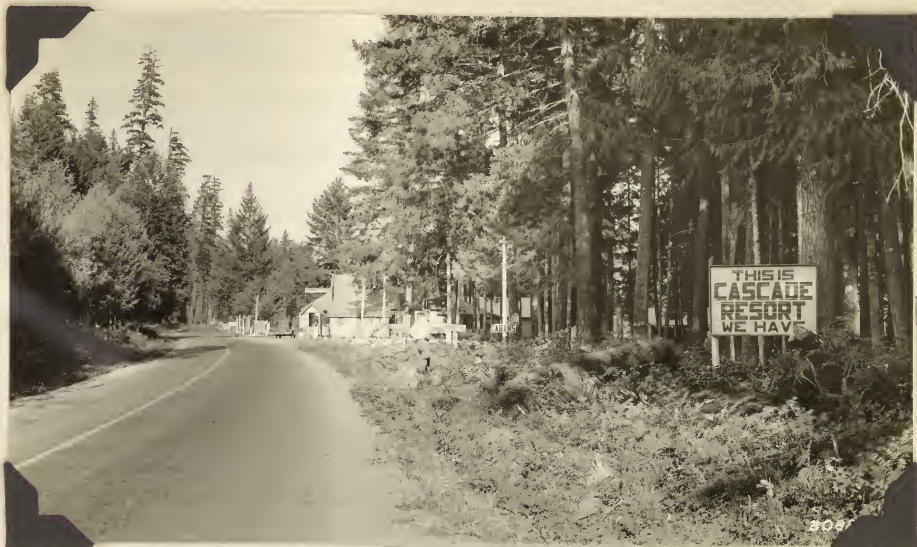
Willamette National Forest - Cascade Resort on McKenzie Highway

Restrictions should be such that private resorts of such an unattractive appearance cannot be developed on an otherwise beautiful forest highway. There should be adequate restrictions to control the development of all areas adjacent to these highways.

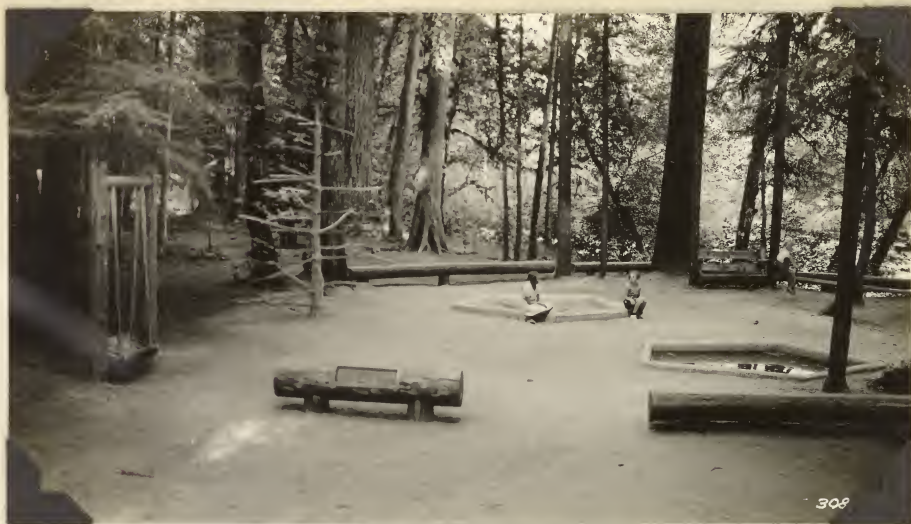
Willamette National Forest - McKenzie Bridge Forest Camp

General view of playground which has been established for children's recreation in a rather large and extensively used camp ground. Such features are most appropriate in this type of camp ground, and I feel their introduction into parts of some forest areas is entirely justified because of the useful purpose which they serve.

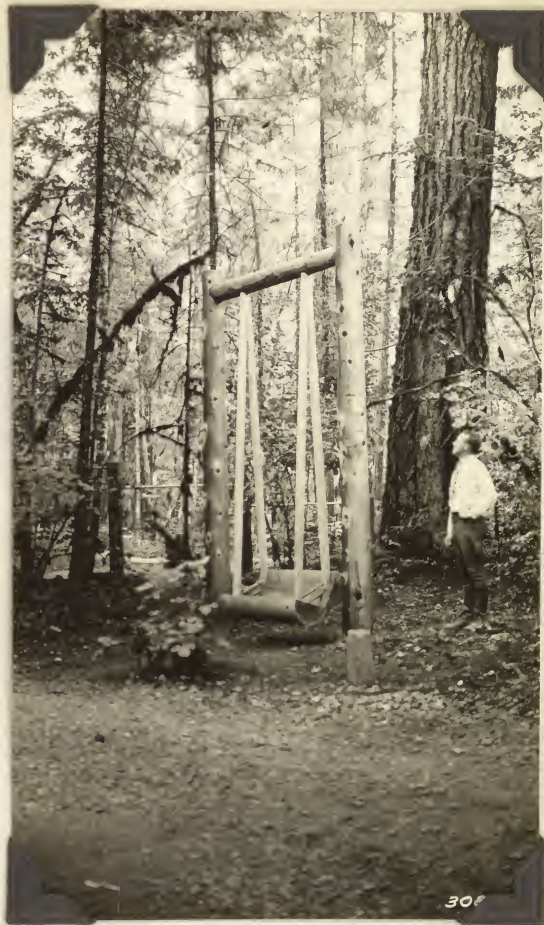
Willamette National Forest
McKenzie Bridge Forest Camp

Detail view of the swings with poles used instead of ropes for suspending it. Note the interesting construction of the seats.

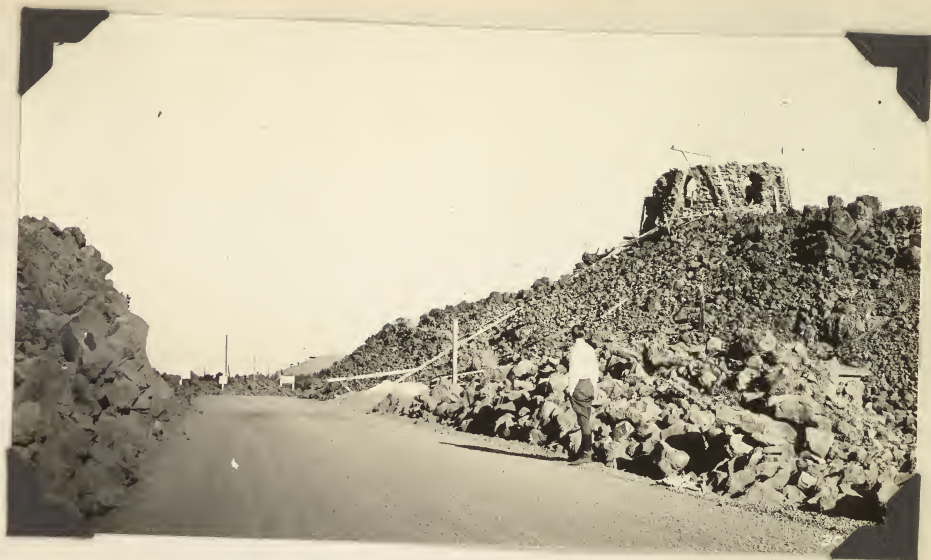
Willamette National Forest - McKenzie Pass

General view of the proposed lava masonry shelter and overlook which is now under construction at the top of the pile of lava rock. Further study should be given to the details of this structure before proceeding with its completion.

At the top of the divide on McKenzie Pass and around the Belknap crater, there is a very extensive area of lava covering approximately 72 square miles. (See photograph No. 308833, page 100.) At the high point of this lava area (see photograph No. 308834, page 100.) a combined shelter and overlook feature is being constructed. Because of the high winds and unfavorable atmospheric conditions, it seems very desirable that some feature be erected in this location.

It is a dominating feature and should be most carefully studied to fit into the surrounding area. I question the advisability, after an inspection of this feature, of proceeding with its construction until a

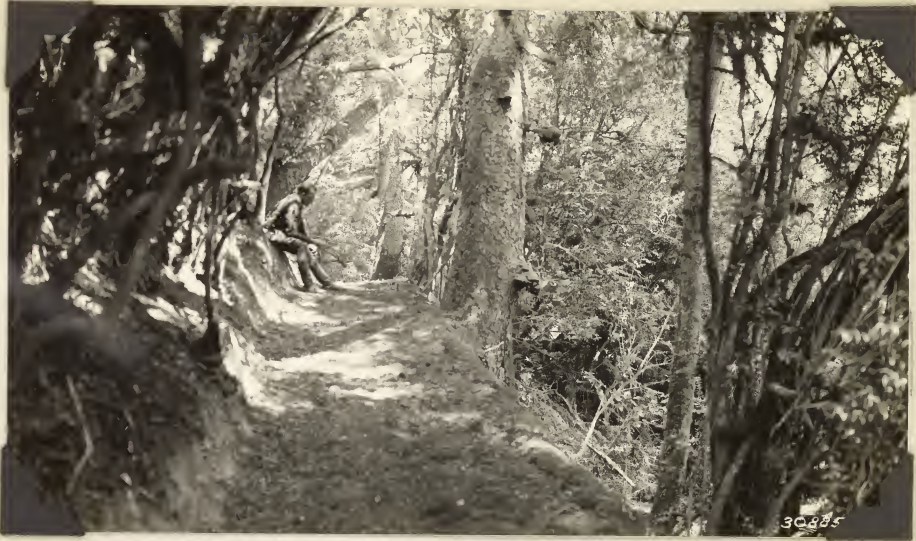
Siuslaw National Forest - Siltcoos Outlet Forest Camp

Detail view of a forest trail leading to the beach through an interesting thicket. The slope of the up-hill side of such trails should be made as gradual as is practicable and yet not unnecessarily disturb or injure the existing growth. This trail is ideal in that it is of adequate width and excellently fitted to the existing topography. (Width of such trails to be no less than 4 feet).

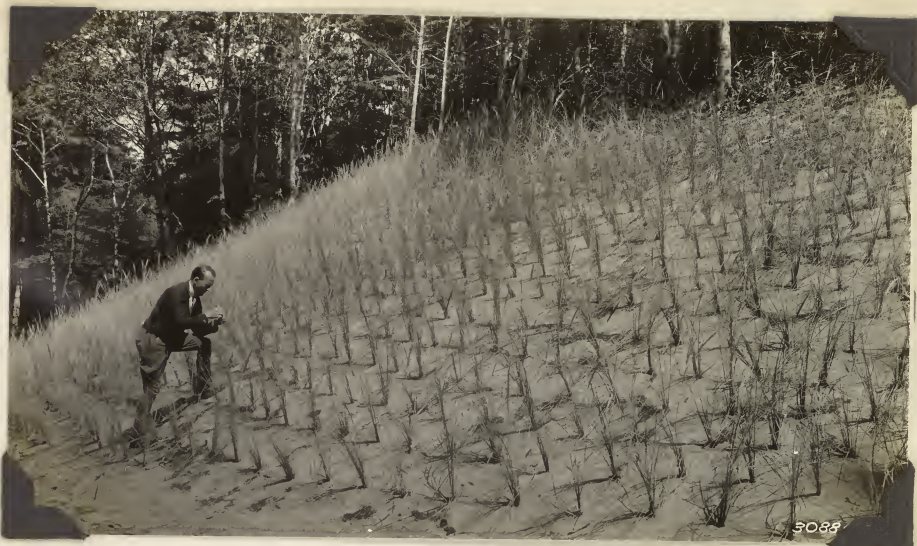
Siuslaw National Forest - Siltcoos Outlet Forest Camp

Detail photograph of sandy slope recently planted with bunches of Holland grass, to prevent erosion and to create an attractive effect.

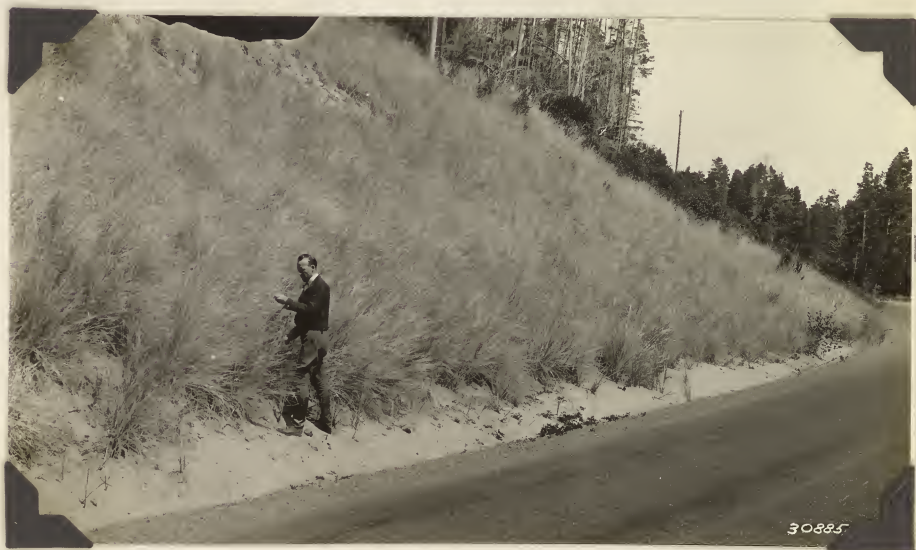
Siuslaw National Forest - near Siltcoos Outlet Forest Camp

A well developed stand of Holland grass, showing the protection and the effect which is produced when this grass matures.

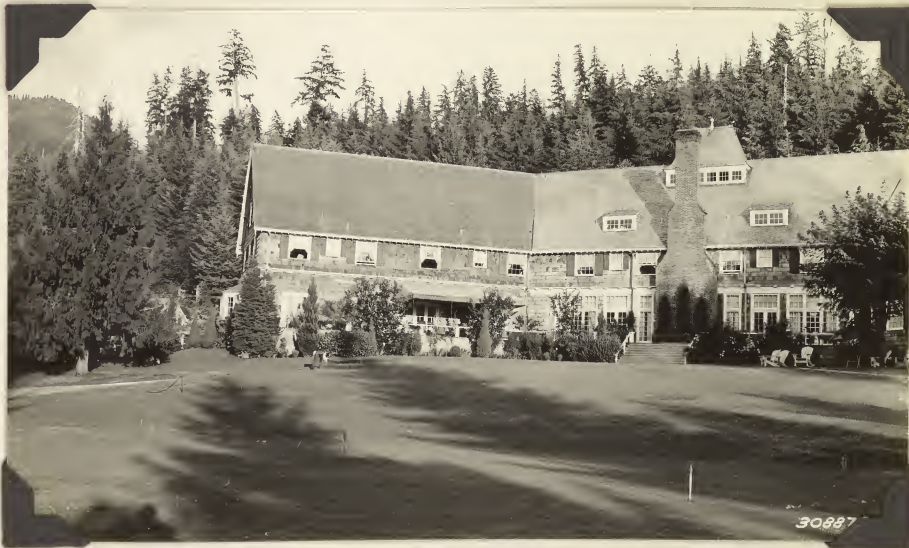
Olympic National Forest - Hotel at Lake Quinault

Detail view of lake front of the Lake Quinault Hotel. This is a most attractive type of structure admirably adapted to its use. One of the dangers in the development of areas surrounding such structures lies in the departure from the use of native materials for a major portion of the planting.

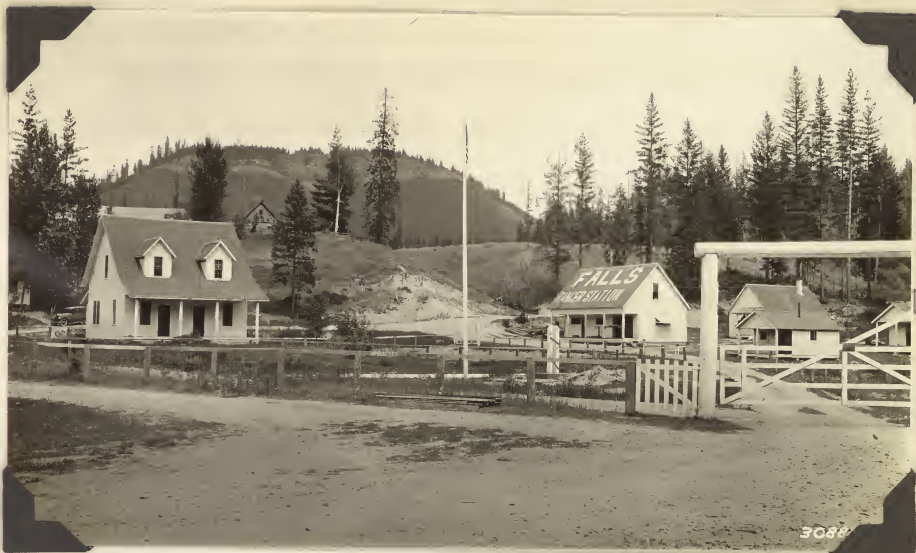
Kaniksu National Forest - Falls Ranger Station

General view of the Falls Ranger Station constructed about 1911. There is need of a new fence across the front of this property, a new and more appropriate entrance feature, and some planting of trees and shrubs to create a proper landscape composition in this area.

This ranger station is located along the west branch of the Priest River Road. It is one of the older ranger stations, developed about 1911 (see photograph No. 308883, page 118). It needs a new boundary fence and it is very much in need of a modified and appropriate entrance feature. I recommend very strongly that further study be given to the important problem of appropriately planting this ranger station area to provide a more attractive setting for the buildings.

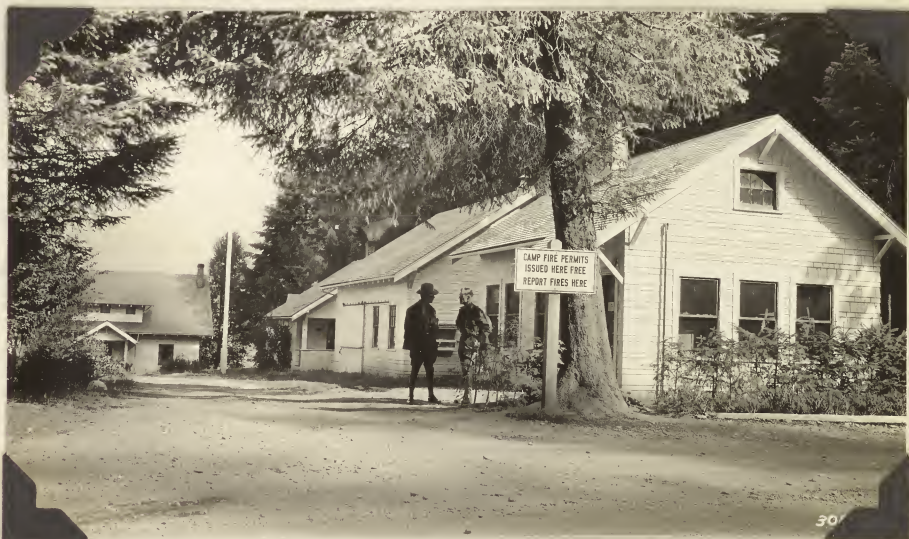
Olympic National Forest - Quinault Ranger Station

General view of Quinault Ranger Station showing some of the buildings now in this group. The advisability of moving some of these buildings to a location on the opposite side of the street is now under consideration. Some consideration should be given to the problem of planting in connection with this ranger station.

This ranger station (see photograph No. 308881, page 118) is located near the Hotel Quinault. I am very much in sympathy with the suggested procedure of removing from this area all of the buildings, with the exception of the ranger's residence, and placing these service buildings in a limited area on the opposite side of the street. A definite plan should then be studied for the development of the area in connection with the ranger station residence, and also in connection with the relocated buildings.

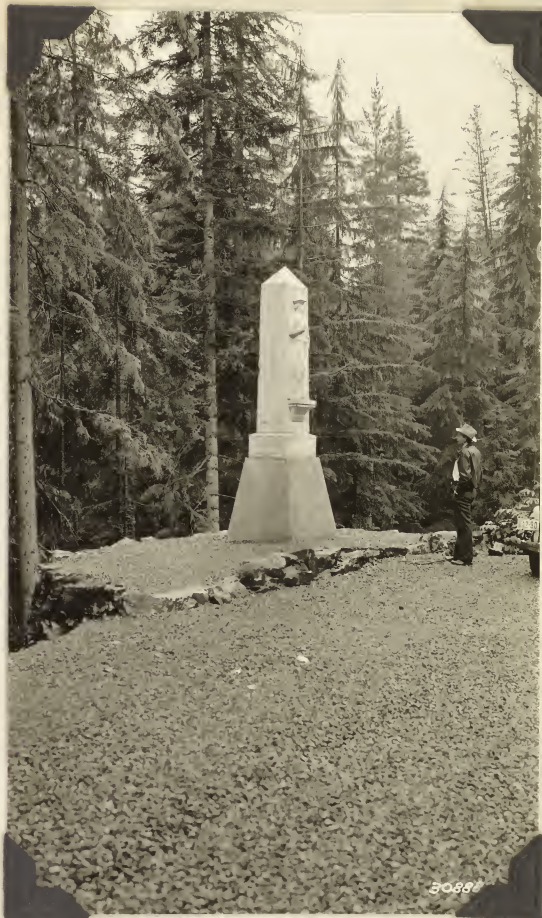
Coeur d'Alene National Forest
Mullan Monument on Yellowstone Highway
(#10)

Detail photograph showing existing conditions around the base of this monument. Monuments of this character should be in a more natural setting, which in this instance, can be created by planting a ground cover on the area around the base of the monument, by removing the unnecessary stones across the front of the area, and by planting a few vines at the base of the monument to partially cover the concrete work.

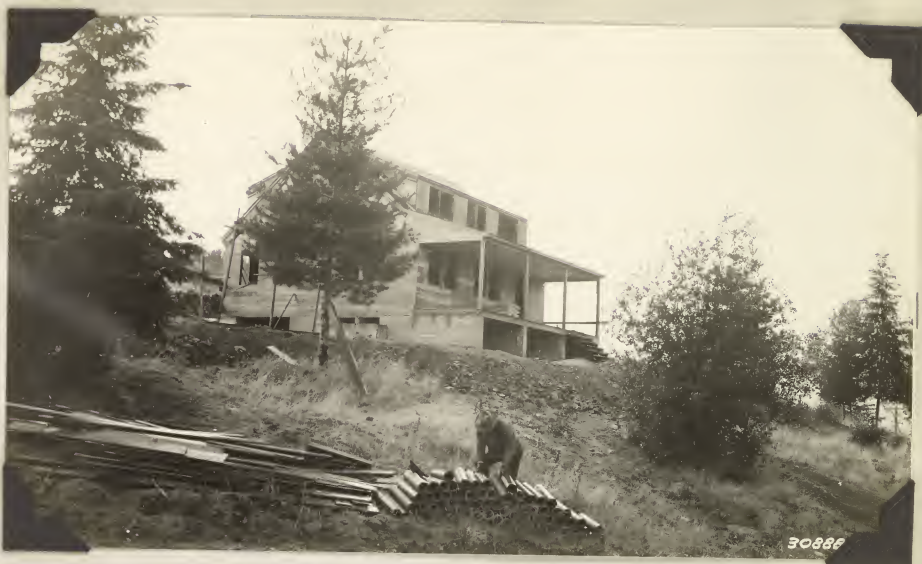
Coeur d'Alene National Forest - Kingston Ranger Station

General view from the proposed entrance drive toward the front of the residence. The floor elevation should have been lowered at least two feet. The area around this building presents a difficult problem of grading and an important problem of planting.

The first floor grade of the ranger's residence should have been set at least 24 inches lower (see photograph No. 308889, page 124) and the building ought to have been located somewhat further back on the slope (see page 125), in order to have taken the maximum advantage of the possibilities for the development of this area. I am making this observation only because of the bearing which it may have upon further studies for other ranger station sites.

There is an important grading problem in the area across the front of this residence, in order to procure a natural slope which will continue down to the top of a low dry stone retaining wall, which ought to be constructed on the upper side of this road.

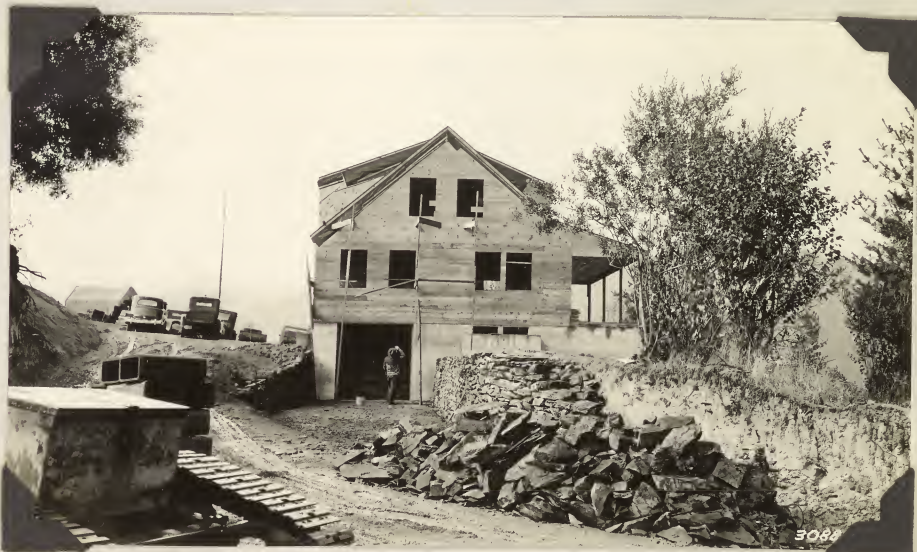
Coeur d'Alene National Forest - Kingston Ranger Station

Detail view looking toward the entrance to the garage at the end of the residence. The abnormally high elevation of the floor grade presents a difficult problem in the grading and planting of the area around the building.

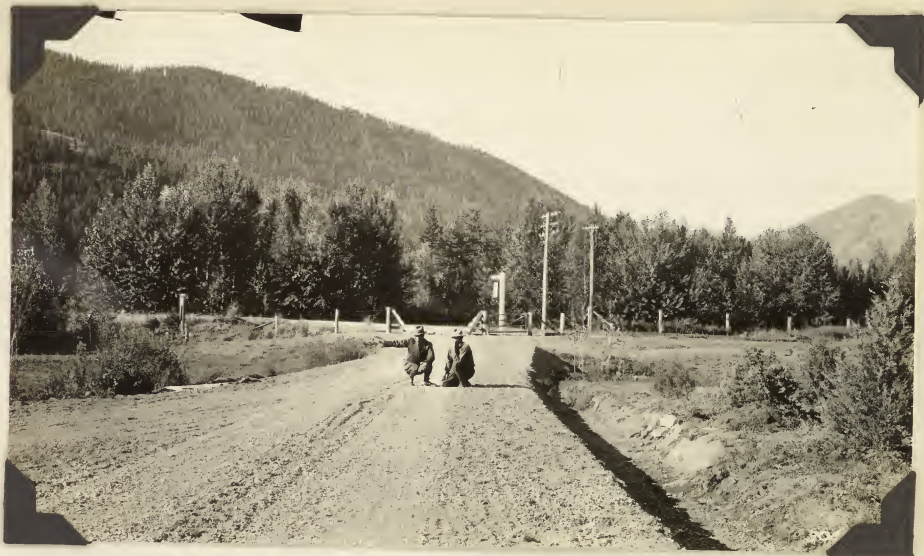
Lolo National Forest - Bonita Ranger Station

General view looking along the entrance drive toward the main entrance to this ranger station property. Note the abnormal width of the drive and the unfortunate appearance of the gutter along the right-hand side of the drive.

The general plan of this ranger station area can be much improved by further study of the proper alinement and widths of the drives. I have marked on the grounds a modified line for the drive leading to the ranger's residence. This drive should be reduced in width to approximately 12 feet and should be a one-way drive, with provision for a proper parking space opposite the entrance walk. The grading along the sides of the drive should be carefully studied, taking into consideration the fact that in place of the present ditches, turf gutters should be provided in

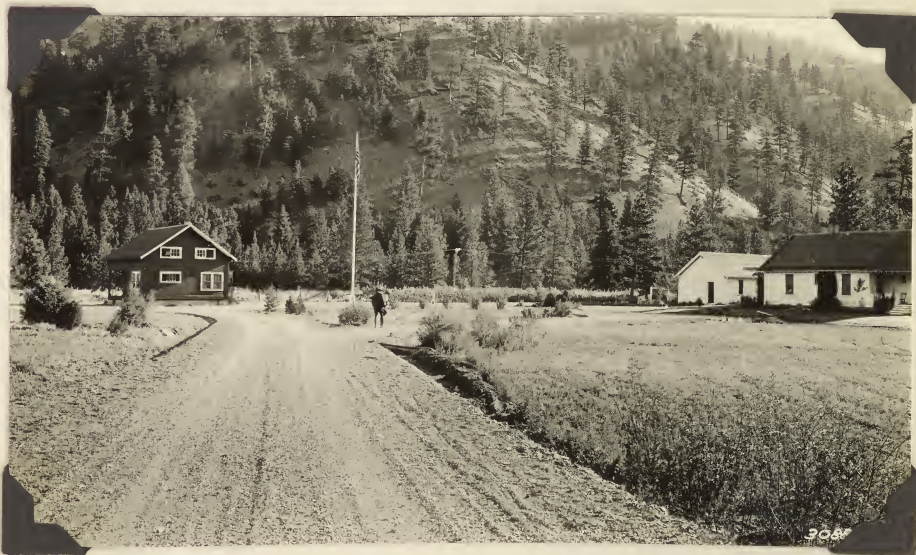
Lolo National Forest - Bonita Ranger Station

General view looking along the axis of the main entrance drive showing the service building in the general service area. This building should be somewhat concealed by appropriate planting.

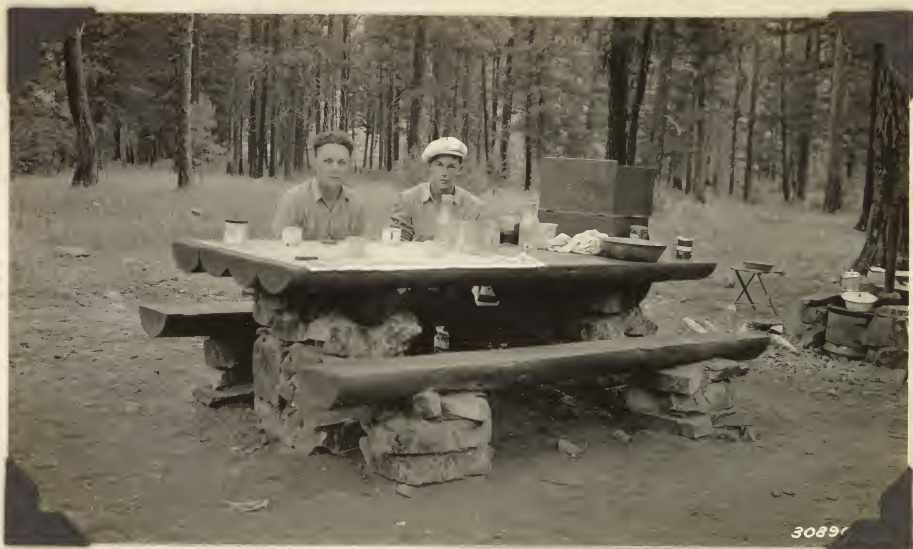
Lolo National Forest - Bitterroot Flats Forest Camp

An interesting type of picnic table of unusual construction. Such attempts to produce unusual rustic effects must be very carefully studied. I do not feel that the additional expense required to produce a camp unit of this type is justified in the majority of camp areas.

An unusual type of picnic table is used in this camp ground area, as shown in photograph No. 308903, (page 131). It does not seem justifiable, however, to go to the expense of constructing a picnic table of this type when so many other excellent and more simple designs can be produced at less cost.

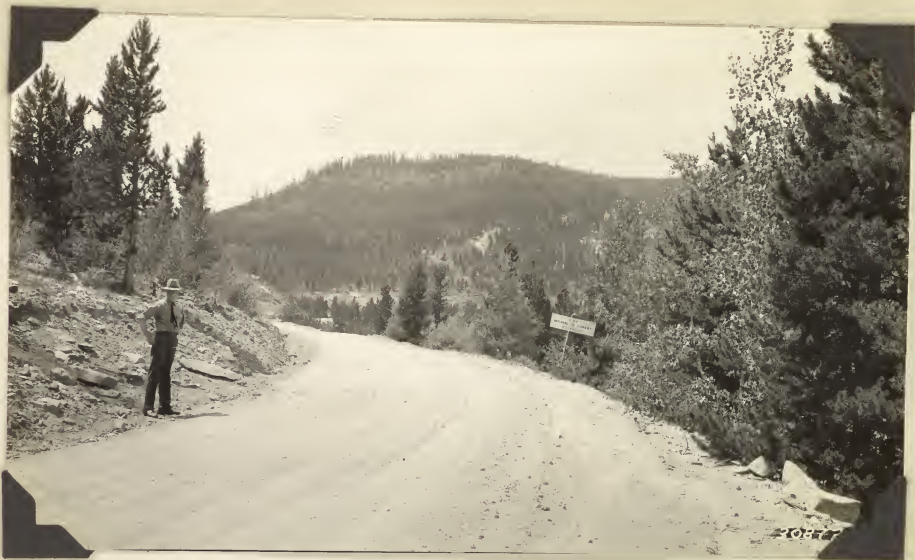
Pike National Forest - Echo Lake Entrance Road

View showing existing conditions at the point of entrance to the Pike National Forest on the Echo Lake Road. A study should be made to determine the appropriate type of entrance feature which ought to be erected in this location.

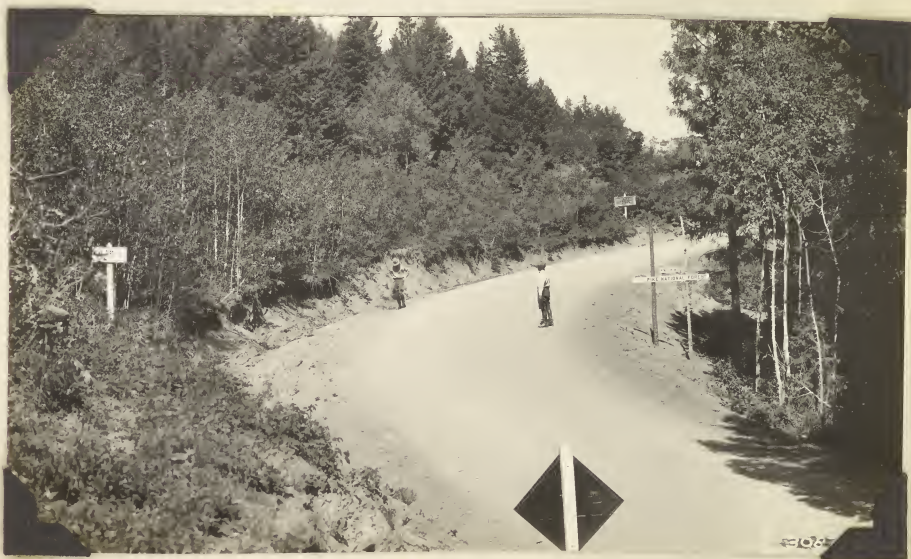
Pike National Forest - Jarre Canyon Entrance

View taken from the top of the bank just below the point where the forest boundary crosses the highway. Note the small signs, one on either side of the existing highway. It is proposed to develop an appropriate entrance feature at this point as a part of a comprehensive program, to designate on all important highways the entrances into the National Forest areas.

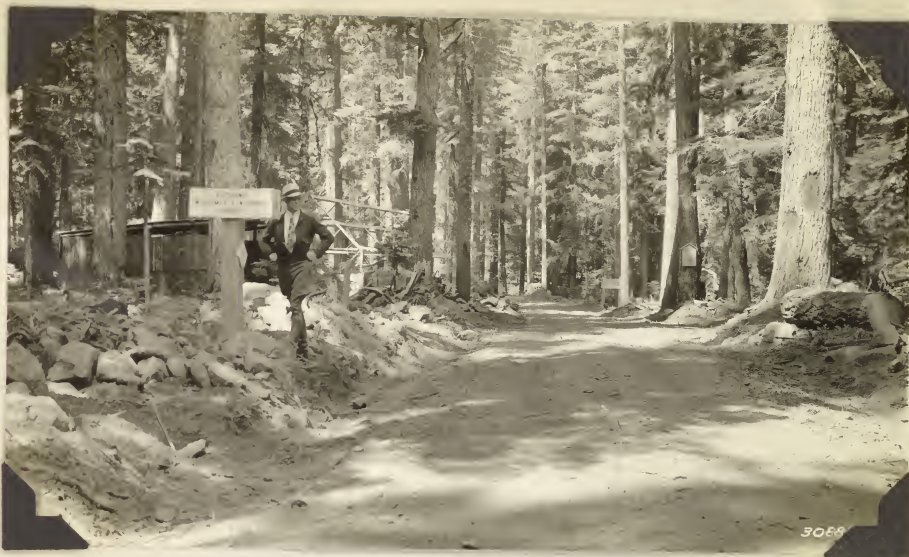
Mount Hood National Forest - Dividing line between the Mount
Hood National Forest and the Willamette National Forest on Highway

A most attractive and appropriate sign should be adopted for such locations. A sign erected in this type of forest surroundings should be very rustic in character and should not have the character of a forest entrance sign. Painted boards and concrete posts, such as used in this location should be discouraged.

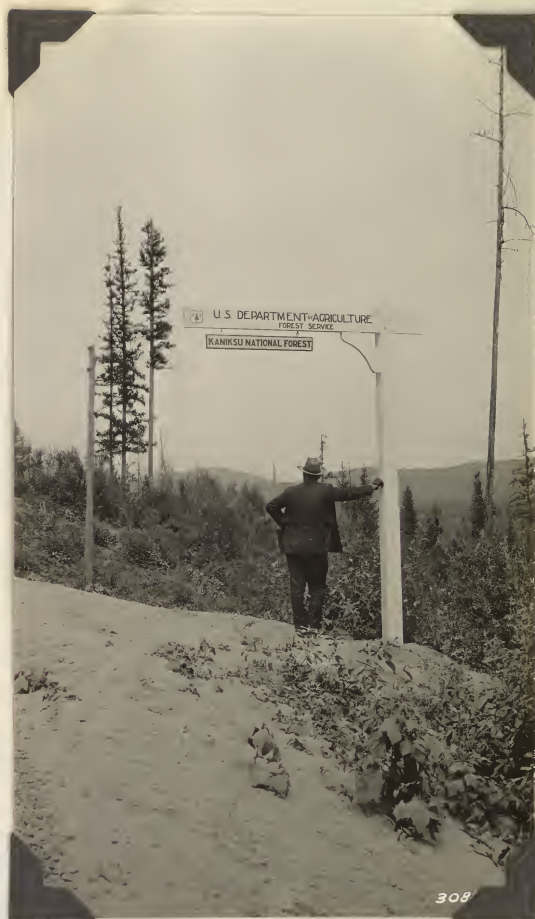
Kaniksu National Forest
Entrance to Forest

This sign marking the forest entrance on the Priest River Road does not seem to be of sufficient permanent character or in proper proportions, to be used in such a location. The sign is made of smooth white pine boards, painted white. It is highly desirable that some more appropriate design and materials be used to define such entrances.

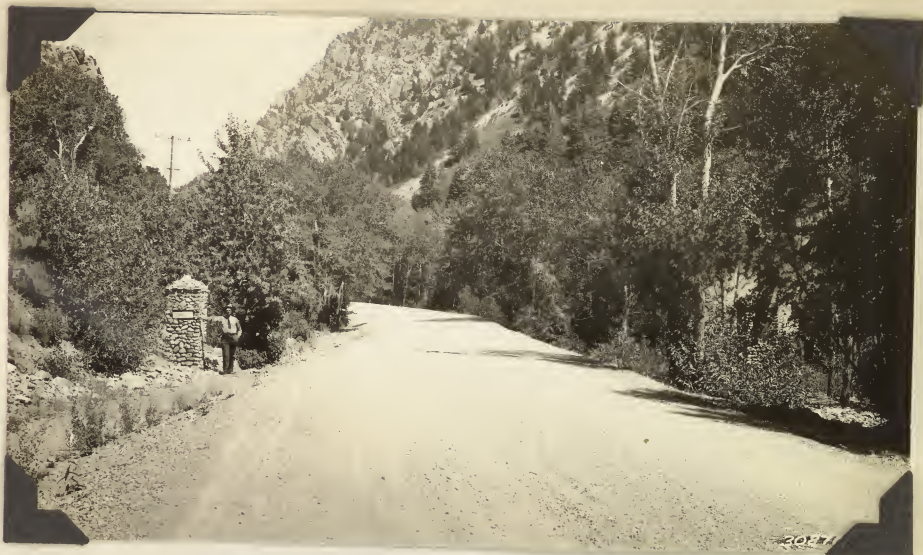
Wasatch National Forest - Alpin Scenic Highway

General view of the forest highway entering the Wasatch National Forest. These piers ought to have been erected nearer to the edge of the highway. The size and texture are inadequate for the scale of this entrance feature. On such wide forest highways I doubt the advisability of erecting two piers because of the abnormal distances between them, which destroy the composition which should exist where a pier is erected on either side of an entrance road. In general, I think the tendency is to locate piers at the forest entrances too far from the edge of the highways.

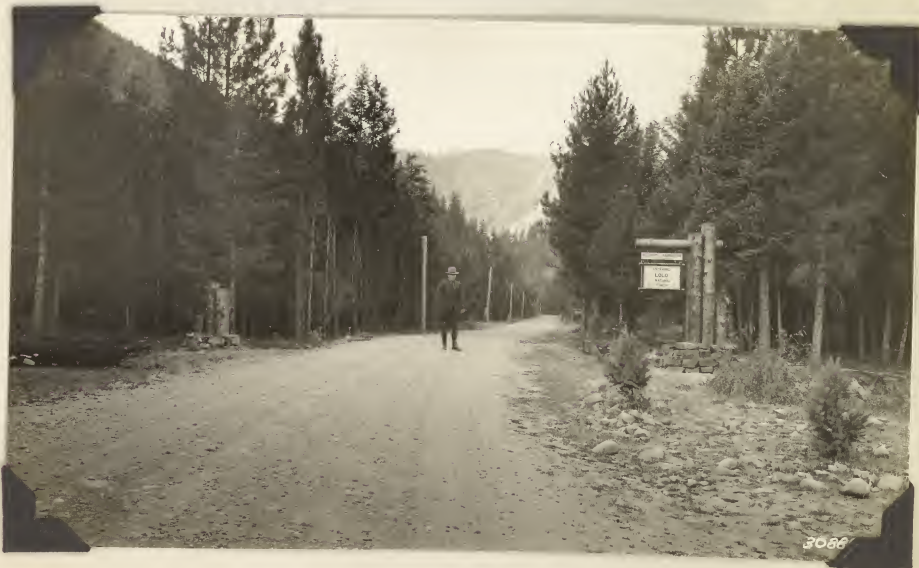
Lolo National Forest - Entrance to Forest Area

General view showing the feature which has been erected to mark the entrance to this forest. The piers are too far removed from the side of the highway.

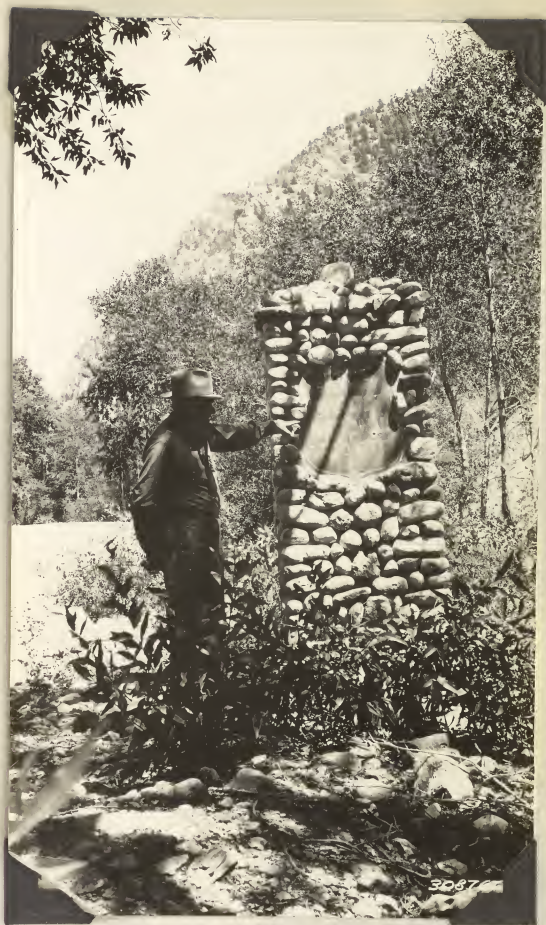
Wasatch National Forest
Alpin Scenic Highway

Detailed view of one of the stone piers which mark the boundary of the forest on this highway. For further comments, see photograph No. 308765.

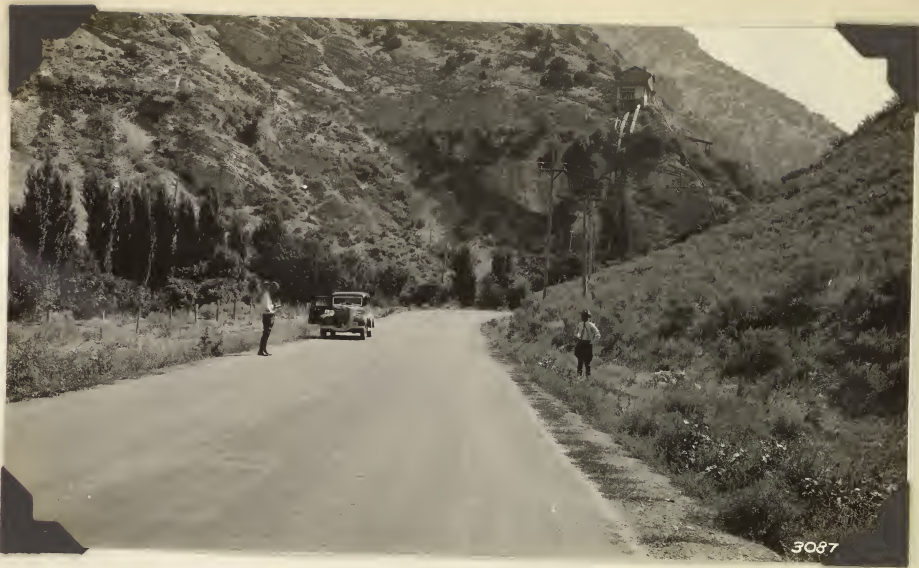
Cache National Forest - Logan Canyon Highway

General view showing the location for the proposed construction of a definite feature, marking the entrance to the Cache National Forest on this highway, leading into Logan Canyon.

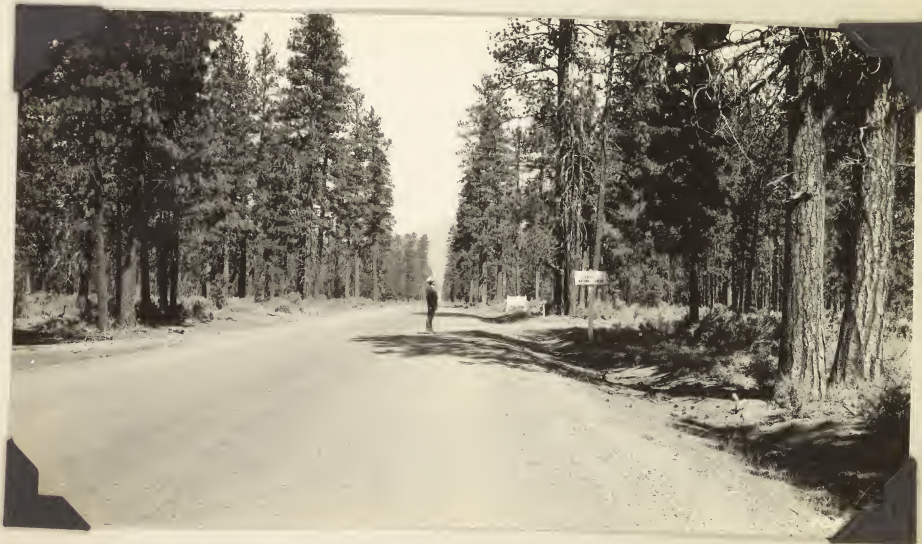
Deschutes National Forest - Entrance on Main Highway

A general view showing the point of entrance to Deschutes National Forest, at which location an appropriate entrance feature should be erected.

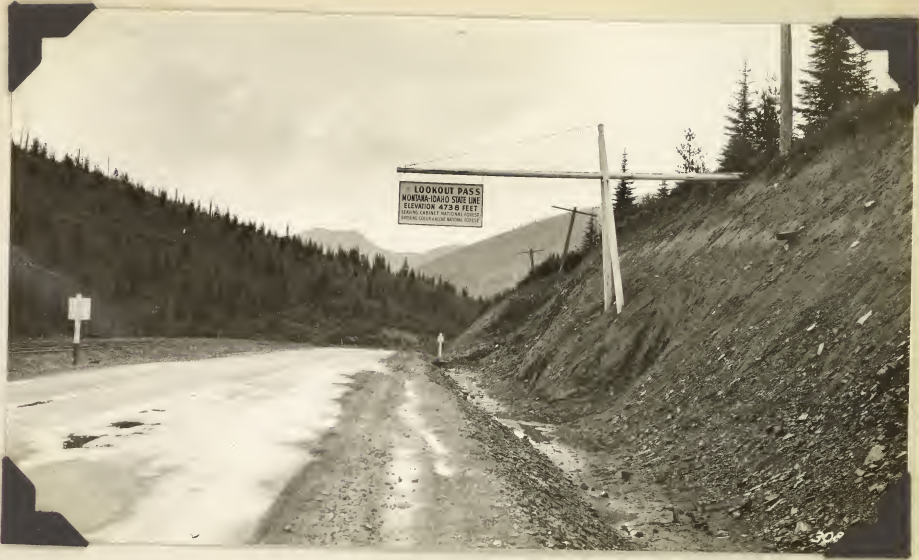
Coeur d'Alene National Forest and Cabinet National Forest

Detail view of boundary sign which marks the division between Idaho and Montana, and also marks the division between the two forests. Such signs are very temporary in character and are entirely inadequate for the purpose for which they are intended. Signs in such locations should be most carefully studied and should be constructed so far as is practicable of permanent materials.

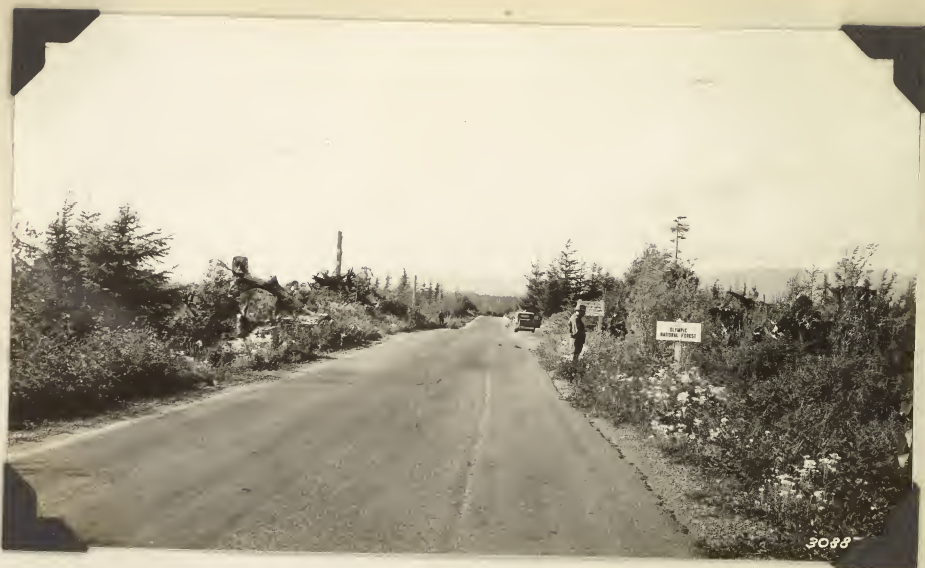
Olympic National Forest - Entrance to Forest

General view showing the point of entrance to the Olympic National Forest. Some appropriate feature should be designed for this location.

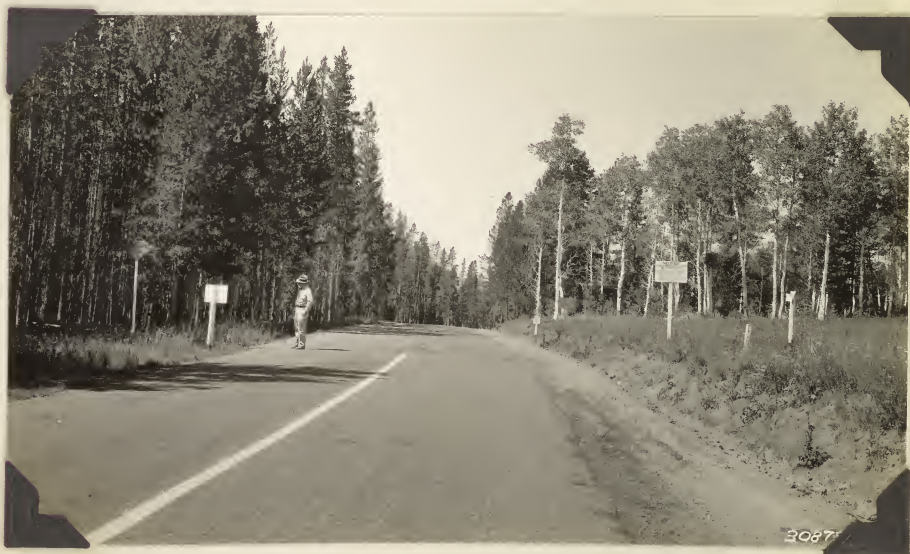
Targhee National Forest and Gallatin National Forest

General view showing the location on Route #191 which marks: (a) the State line between Idaho and Montana, (b) the dividing line between Targhee National Forest and Gallatin National Forest, and (c) the "Divide". The question is now being considered concerning an approach marker to designate this important spot.
